THE SEVENTH REGIMENT ARMORY ON PARK AVENUE

A site inspection was conducted July 22, 1999 with the Armory superintendent. Maintenance of the third and fifth floors is by the Lenox Hill Neighborhood House and not state personnel. A representative portion of the rooms was inspected. Areas not investigated included the rifle firing range and the adjacent kitchen in the basement and the restaurant and kitchen on the fourth floor. The following information does not constitute a full Phase I environmental site assessment (ASTM Standards on Environmental Site Assessments for Commercial Real Estate, Standard E 1527-94 and E 1528-93).

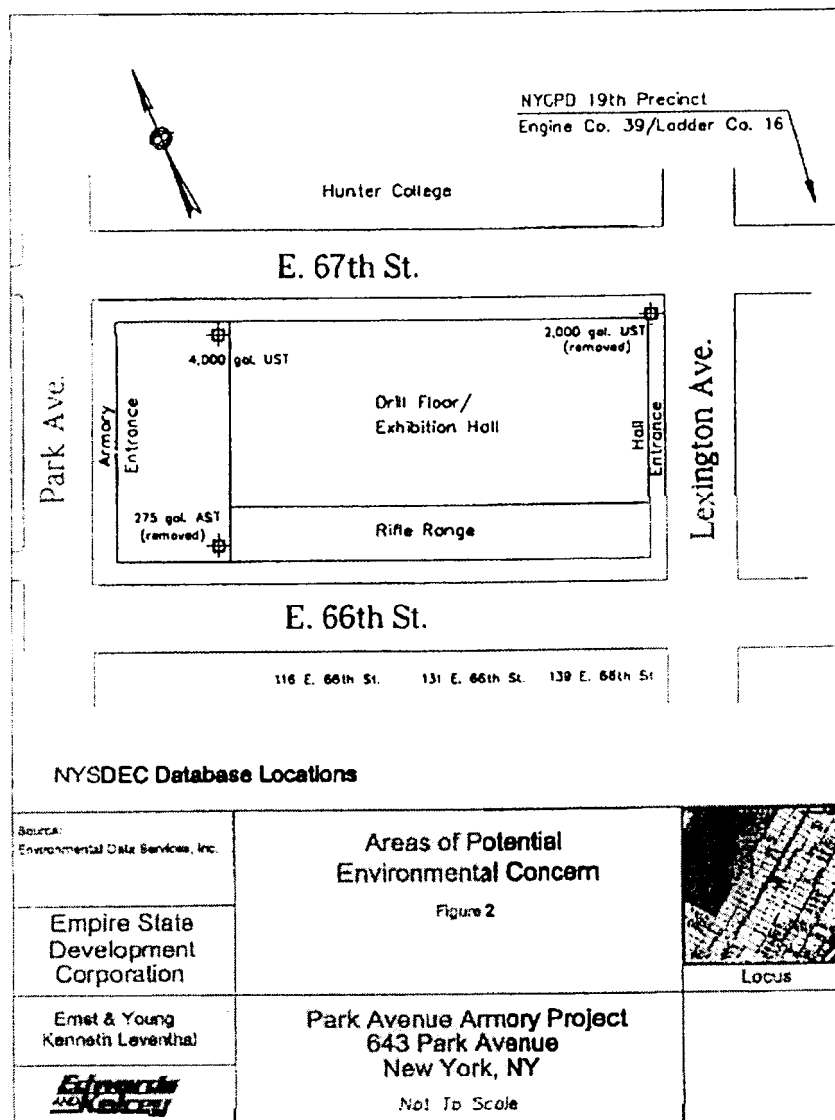
Three tanks are listed at the project site on the NYSDEC Petroleum Bulk Storage (PBS) Underground Storage Tank (UST) and Aboveground Storage Tank (AST) lists. The relative location of these tanks is presented in Figure 2 below.

A 4,000-gallon steel/carbon steel UST, vaulted, with access, is located in the basement of the armory. This tank, installed in July, 1968, is used to store No. 1, 2 or 4 fuel oil.

According to the state database, a 2,000-gallon steel/carbon steel UST, installed in 1960 and used to store unleaded gasoline, was closed and removed in April, 1994. According to the Division of Military and Naval Affairs (DMNA), actually two (2) 500-gallon tanks were located on the exterior of the building along East 67th Street near the intersection with Lexington Avenue. Soil samples taken in the tank excavation area indicate that the constituent levels were well under the regulatory limits established by the New York State Department of Environmental Conservation ("NYSDEC").

A 275-gallon AST on saddles, legs, stilts, or cradle, installed in 1975 to store diesel, is currently out of service.
